TECHNICAL REPORT

NO. 12498

FORMATION AND FAILURE OF
ELASTOMER NETWORKS VIA
THERMAL, MECHANICAL AND
SURFACE CHARACTERIZATION

U.S. ARMY TANK-AUTOMOTIVE
RESEARCH AND DEVELOPMENT COMMAND
Warren, Michigan 48090

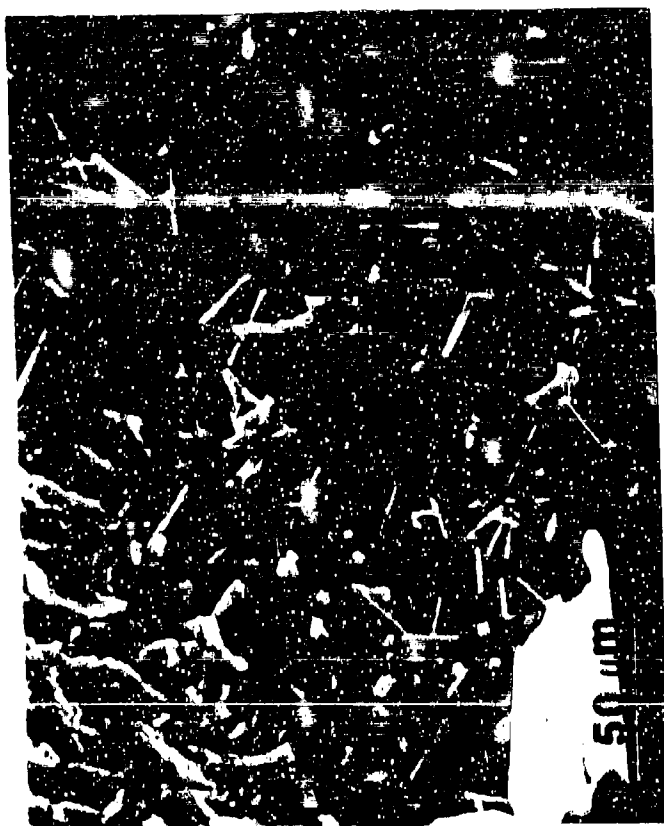
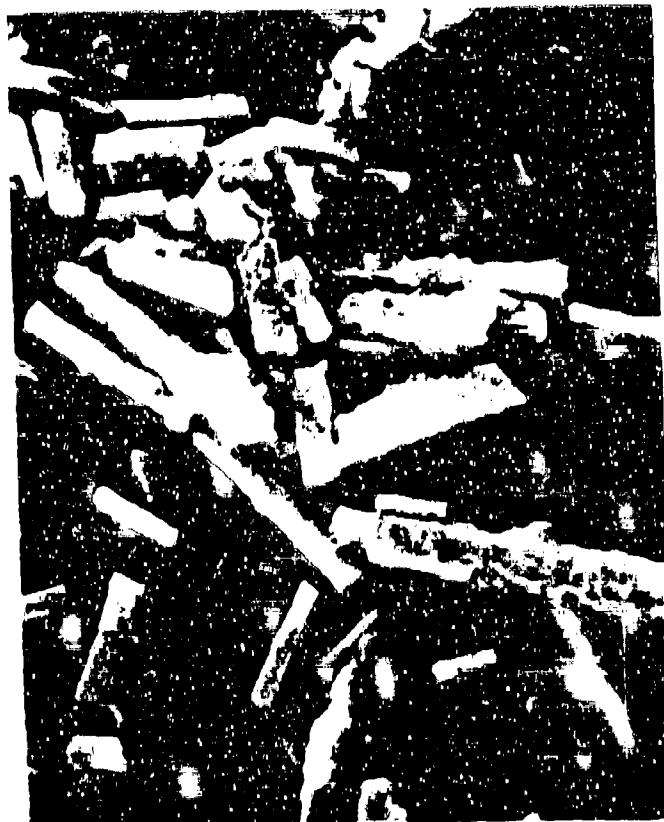
Figure 7

EDAX detected Al, Cl, Si, K, Ca, Fe, and Zn in the bulk and in the particles on the surface. The needle-like particles shown in fractographs are confirmed by ESCA and EDAX to be zinc oxide as was suspected. The agglomeration of ZnO particles on the failure surfaces could certainly be involved in the premature failure of the track pads. These layers appear to be primarily "aliphatic" material derived from the polydiene component of the SBR. The presence of the ZnO particles suggest that the blending of the rubber with the compounding ingredients, is inadequate. More intensive mixing with longer time cycles are suggested.

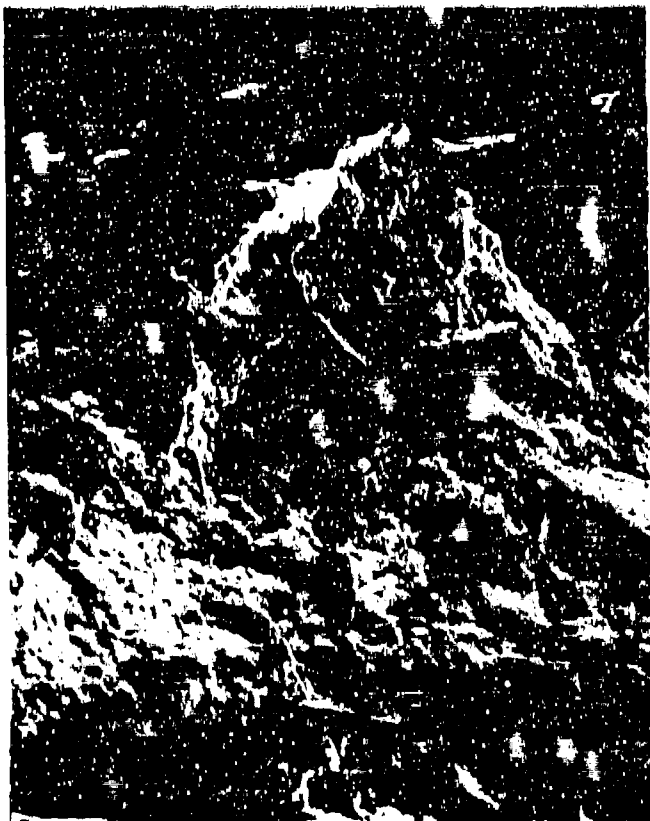
Figure 9

Chunky fracture surfaces of degraded rubber were observed at progressively higher magnification and underscore the effects of mechano-chemical and thermo-oxidative degradation: Micron-sized granular structures are created, and cracks propagate easily through this type of matrix.

The granular appearance of fractographs is believed to be significant and probably results via the combined degradative action of stress, oxygen and heat. Further measurements of swelling and thermal analysis (DSC, TGA, and TMA) should further elucidate these observations.

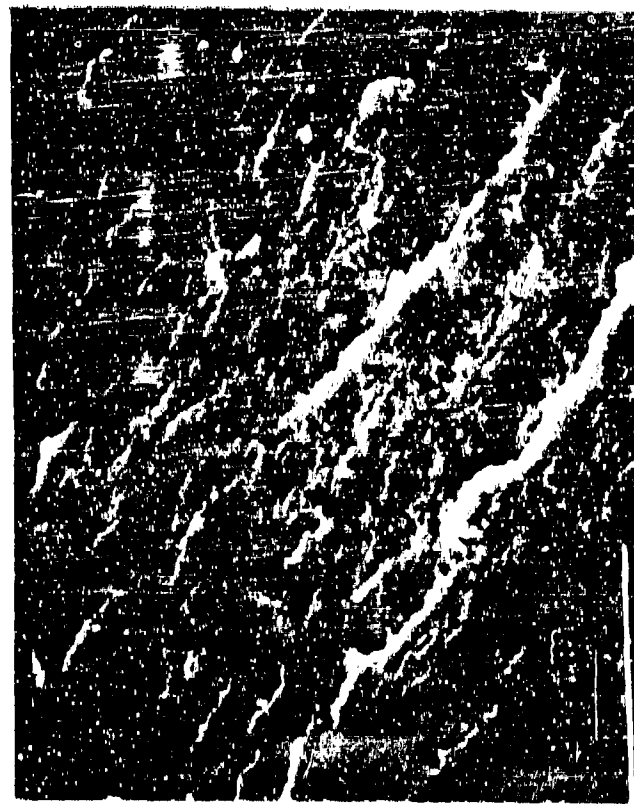
Figure 11

Fracture surfaces derived from tensile test specimen showed no ZnO particles on the fracture surfaces of the controlled St. Joe materials. On the other hand, the ZnO particles were observed on the surfaces of the failed pads. It would be of interest to observe whether inhomogeneities

Each of the St. Joe samples was failed in tension, before and after exposure to 325°C for 5 and 10 minutes, and about 75% and 90% drop in stress-strain properties was noted. However, SEM examinations of all fracture surfaces never showed ZnO, even in the case of high aspect-ratio, acicular particles. Presumably this reflected very good mixing, which should be emulated by the commercial elastomer systems.

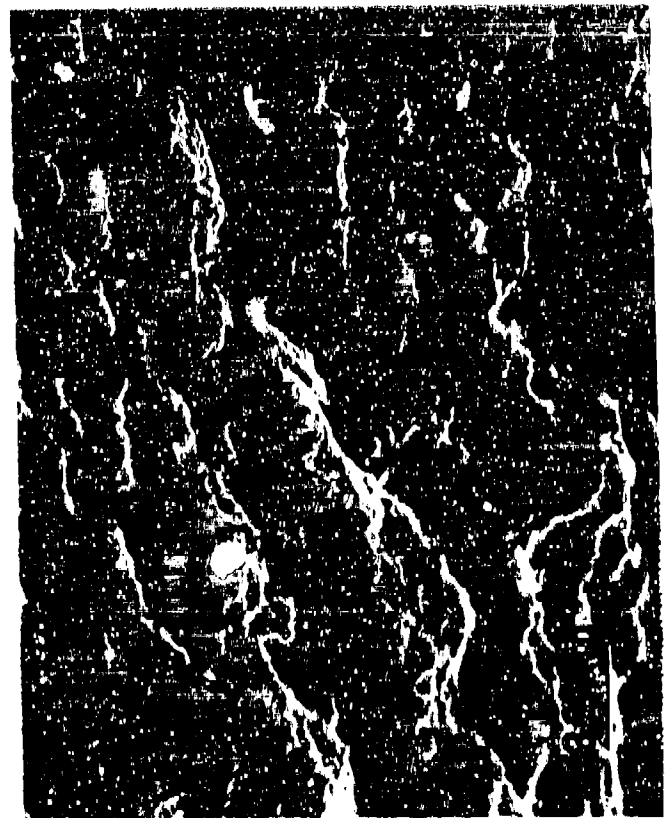
Figure 12

<u>Figure No.</u>	<u>Description</u>
7	Zinc oxide particles - peel test sample
8	Zinc oxide particles - field service failure
9	Granular failure surface showing increasing magnification of crack tip region
10	Top - "Mud cracked" appearance of pad surface that looks perfect by eye Bottom - More granular field failures
11	St. Joe Zinc Company "model" specimens tensile failure surfaces Top - after 300°C for 10 minutes Bottom - as received (cured) Note differences in these surfaces compared to field failure surfaces
12	"Cabbage-leaf" type field failure, series of increasing magnifications
